Stability Causes of Ab-Ask landslide dam in Haraz river

Abstract

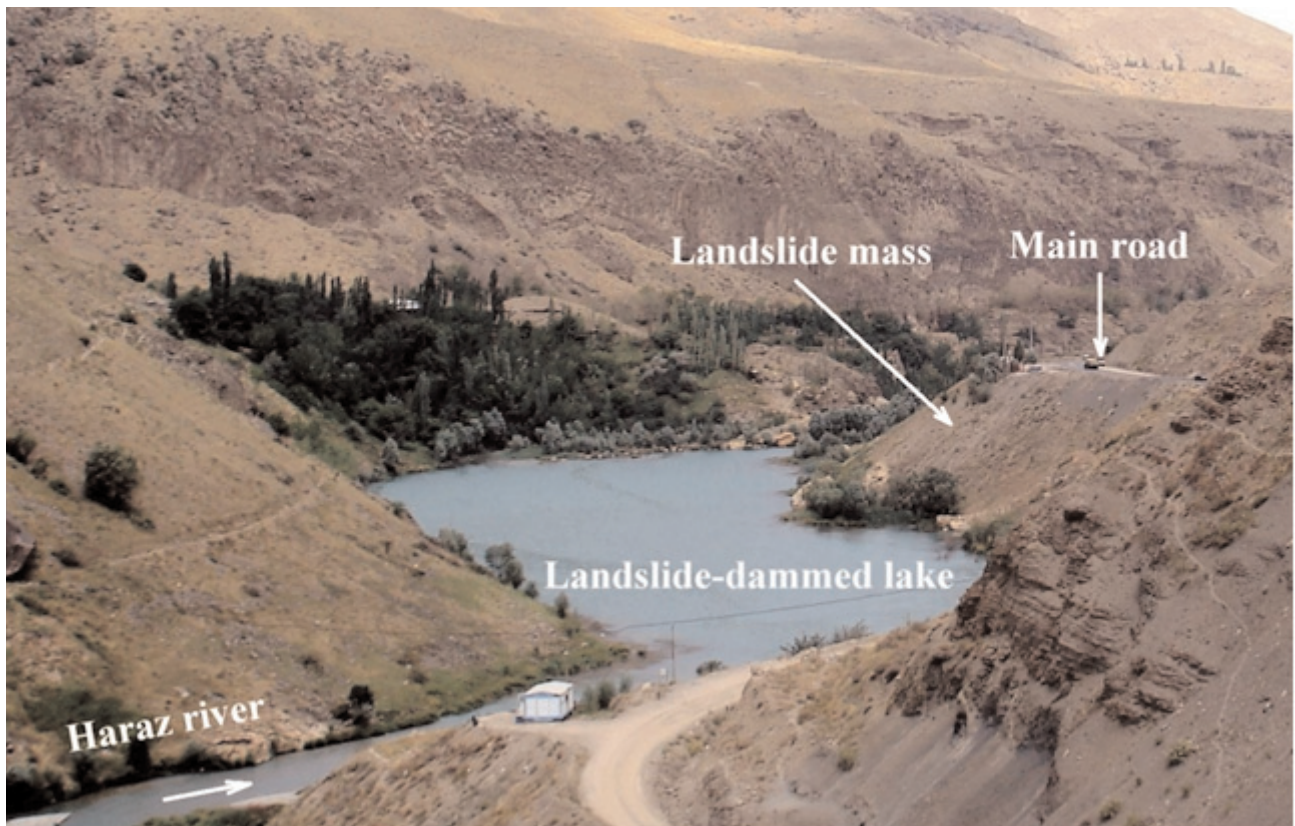
Figure 3. Ab-Ask landslide-dammed lake and landslide dam (foreground), view to the north.

Most of Haraz river landslides have occurred along the steep slopes and on the deposits of Shemshak Formation. These landslides have taken place on alternating coal shale and sandstone. Moreover, the presence of active faults next to landslide masses proves the role of tectonic crushing's in magnifying the landslide potential. Ab-Ask landslide and the associated lake, 70 km northeast of Tehran and 68 km south of Amol, is a typical case of landslide in the

region (Pourghasemi et al. 2003) (Fig. 3).

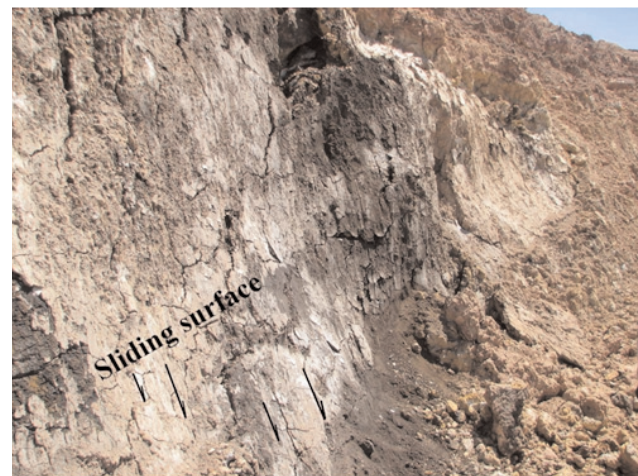
Figure 6. the former sliding surface due to the retrogressive slide.

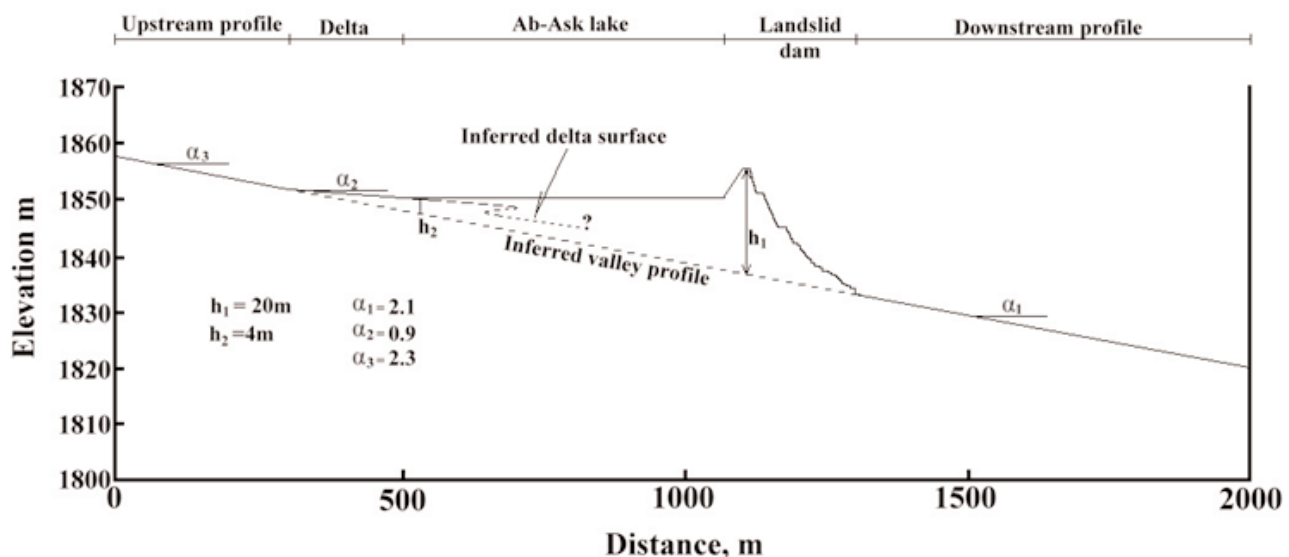
Figure 8. Longitudinal profile along the Haraz River. The profile extends toward 700 and 300 m downstream and upstream from the Ab-Ask landslide mass, respectively. Note landslide dam, related lake and delta formed at the upstream were crossed along the profile.

The dimensions of the Ab-Ask landslide according to the IAEG Commission on Landslide WP/WLI (1990) are tabulated in Table 1. The parameters of the length and the width of the landslide were obtained from the cross-sections (Fig. 4) and the geomorphological map that was acquired from the 1/50,000 scale topographic maps with a contour interval of 10 m. Because the landslide mass filled the valley floor, the depth of the displaced mass could not be estimated. Based on the cross-sections (see Fig. 4), the depth of the sliding surface is about 10 m at the upper part of the landslide. In contrast, the depth of the rupture surface toward the valley floor, where the main landslide mass accumulated, reached 20 m (Fig. 8).

ly as 4 m by projecting the gradient to the longitudinal profile of the valley (Fig. 8).

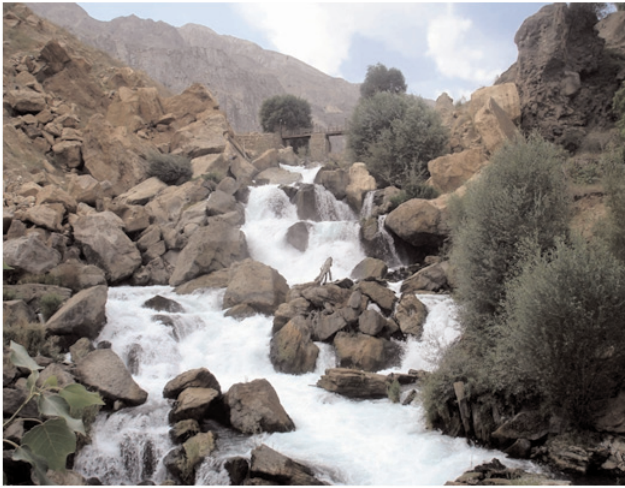
Figure 9. water fall and natural water overflow from the northern part of the landslide mass.

After filling the reservoir, the lake was overtopped from a terrace, where is located at right hand abutment and the landslide mass accumulated, and a natural spillway was cut by the river. Overtopping water created a marvellous water-fall at the tip of the landslide dam (see Fig. 9). The water-fall is 12-m wide and 20-m high, having a discharge of 12 m³/s in the spring time.

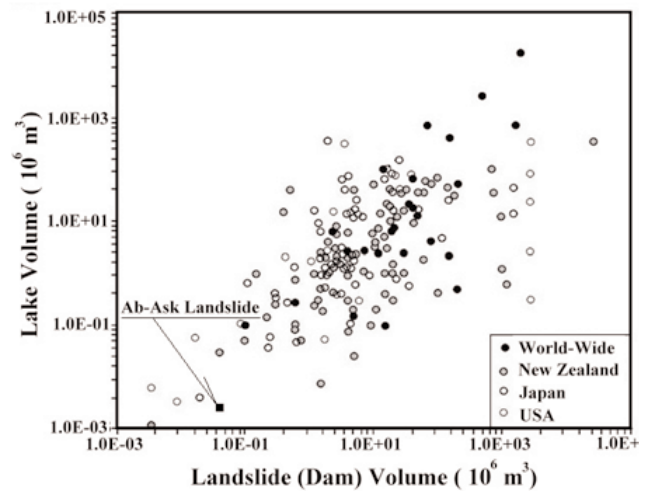
Figure 10. Bivariate plot of landslide-dammed lake volumes versus landslide dam volume derived from a worldwide data set (n=184), highlighting occurrences in New Zealand, Japan, and the USA according to Korup [13] and data from Ab-Ask landslide dam and landslide-dammed lake.

slide dams volume and landslide-dammed lake volumes of 184 examples of worldwide data in a graph. Based on this graph, Ab-Ask landslide-dammed lake is of 65100 cubic meters landslide-dammed lake volume and 5700000 cubic meters of landslide-dammed mass and thus among small landslide dams. (Fig. 10) For the prediction potential for landslide dam stability, Korup (2004) proposed six indices that are the Blockage Index, the dimensionless Blockage Index, the Impoundment Index, the Backstow Index, the Basin Index and the Relief Index (Table 6). Casagli and Ermini, (1999) applied the Blockage Index and the Impoundment Index to the cases in the Apennines, Italy. Ermini and Casagli, (2002) examined 83 worldwide sites for the dimensionless Blockage Index. Korup (2004) presented results from the Blockage Index, the Impoundment Index, the Backstow Index, the Basin Index and the Relief Index based on available data from New Zealand landslide-dammed lakes. Weidinger (2004) suggested the Block Size Stability Diagram. The diagram correlates the grain, boulder and block size of landslide material and the stability of a dam, with the result that the greater the average diameter of the components, the longer the life of the dam and lake. Davies and McSaveney (2005) pointed out the impli-

The indices introduced by Korup (2004), present precious information about landslide dams. Moreover, they enable us to predict the future conditions of landslide mass. The blockage index of Ab-Ask landslide dam is 6.8 and above the threshold ration of
