Investigation of In-Situ Compressive Strength of Fiber-Reinforced Mortar and the Effect of Fibers on the Adhesion of Mortar/Steel

Abstract: The proper connection between mortar and steel is one of the crucial issues in civil engineering. This paper has investigated the effect of polypropylene fibbers on the bond between cement mortar and steel, using “Twist-off” and “pull-off” tests. Moreover, in order to assess the in-situ mechanical properties of fibre-reinforced mortars, the correlation of records obtained from semi-destructive methods of “Twist-off” and “pull-off” with those of laboratory tests was determined, and calibration curves were provided, using the regression analyses. The mentioned tests were modelled with the ABAQUS software to evaluate the distribution of stresses and cracks developed during the semi-destructive tests. The results show that the addition of polypropylene fibbers reduces the shrinkage of mortars by about 13% and this has a direct effect on the bond between the mortar and steel. So that the shear and tensile bond of fibre-reinforced mortars at 90 days is 75% and 94% higher than conventional mortars, respectively. The reason for this is the effect of f

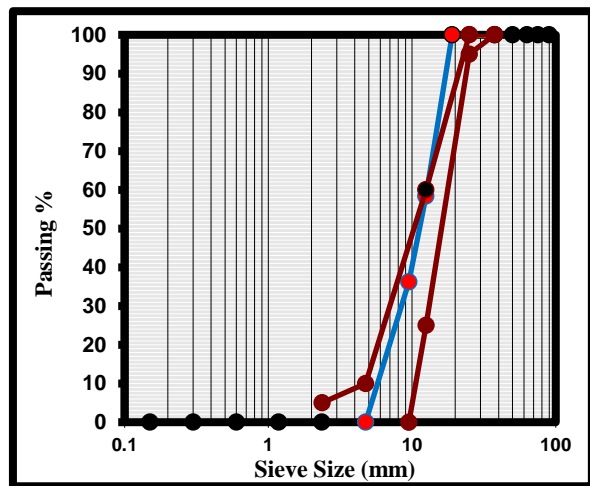
Fig. 1 Aggregate Grading Diagram.

Type II cement, with a density of 3007 kg/m³, was used to make mortars. The densities of saturated surface dry sand is 2510 kg / m³, and their maximum sizes is 4.75 mm. Water absorption of sand is listed as 3.2% according to ASTM C127 [23]. The polypropylene fibbers with the specifications listed in "Table 1" were used. The fibbers were used with 0.3% mortar volume. Figure 1 shows the aggregate grading

(a): Coarse-Grained

(b): Fine-Grained

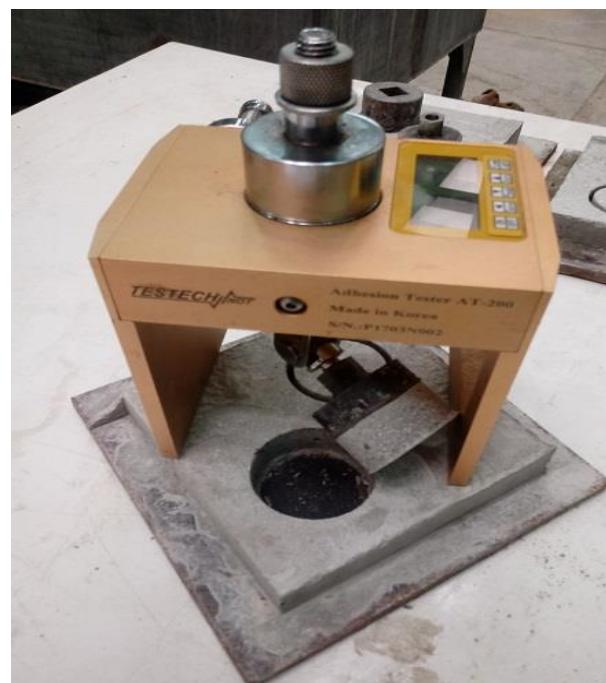
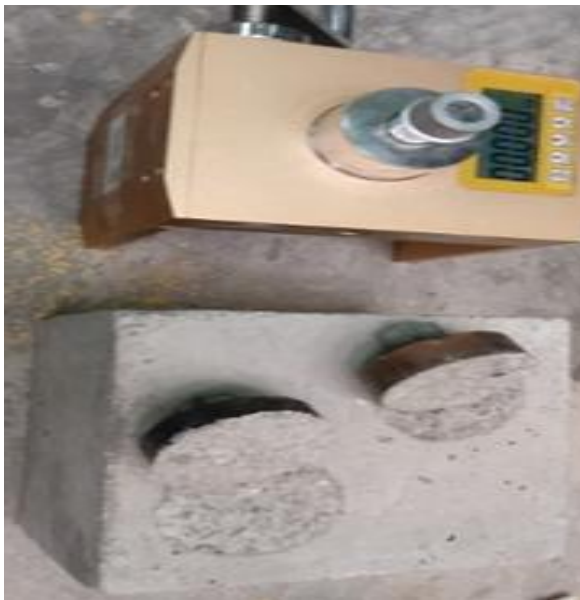
In the "pull-off" test, to determine the bond between the mortar and the steel, a core with a 50mm diameter is first mounted on the test surface using a diamond drill bit and a metal cylinder with a diameter of 50 mm and a thickness of 20 mm is attached to the partial core. Then, the tensile force is applied to the cylinder by means of a "pull-off" device to make the partial core fail (“Fig. 2a”). Furthermore, according to “Fig. 2b” , the aforementioned metal cylinder is attached to the mortar surface and tensile force is applied to it without coring to determine the relationship between the results of the "pull-off" test and the compressive strength of repair mortars.

(a): Bond strength

(b): Mechanical properties
Fig. 2 Performing the "pull-off" test.

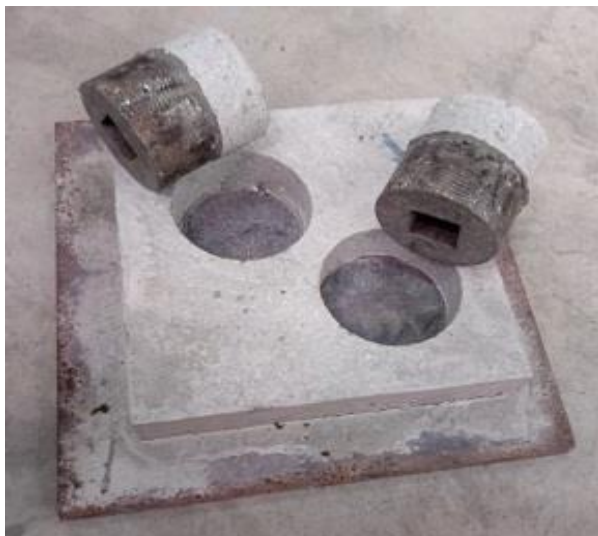
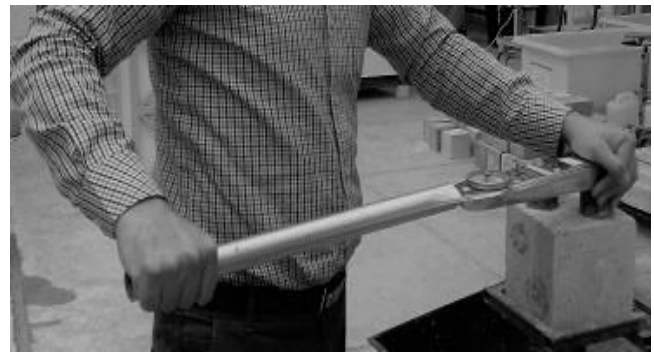
The twist-off test was applied to determine shear bond strength. In the twist-off test, the core drilling machine first created a partial core from the mortar to the substrate steel surface, then the steel cylinder was bonded to the core surface using Epoxy resin-based adhesives, and a conventional torque wrench inserted a twisting moment into the steel cylinder to separate the core from the steel surface ("Fig. 3a"). Moreover, in order to evaluate the mortar compressive strength, 150 mm cubic samples were made and a steel cylinder was adhered to the surface without core drilling; after which a twisting moment was inserted into the steel cylinder by using Torsion Testing Machine to separate crushed mortar and the cylinder from mortar surface ("Fig. 3b").

(a) Bond strength

(b) Mechanical properties
Fig. 3 Performing the "twist-off" test.

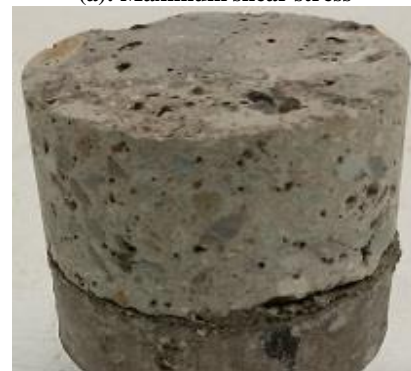
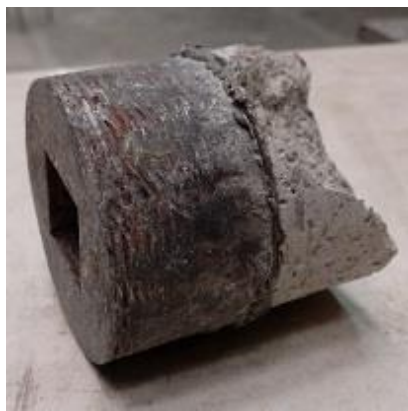
Fig. 4 Creation of Stress and Failure in the "Twist-off" Method.

As can be seen in "Fig. 1a", the partial core is a cylinder with a circular cross-section in this method. As it is evident in "Fig. 4a", if the twisting moment is applied, maximum shear stresses will occur on the circumference of the circle that has the furthest distance from the centre. The failure between common surfaces has different forms: failure occurs at the common boundary between the repair mortar and the steel substrate ("Fig. 4b") or failure occurs within the mortar ("Fig. 4c"). Given that maximum stress occurs at the farthest distance from the centre if a composite failure occurs, "Fig. 4c" shows that failure did not occur at the centre but at the farthest distance from the centre.

(a): Maximum shear stress

(b): Failure at common boundary

(c): Composite failure

The maximum shear stress created by the twist-off method is calculated as "Eq. (2)".

$$\tau_{E-max} = \frac{T_r}{J}, J = \frac{\pi r^4}{2} \rightarrow \tau_{E-max} = \frac{2T}{\pi r^3} \quad (2)$$

Where, r is the radius of the partial core and J is the polar moment of inertia.

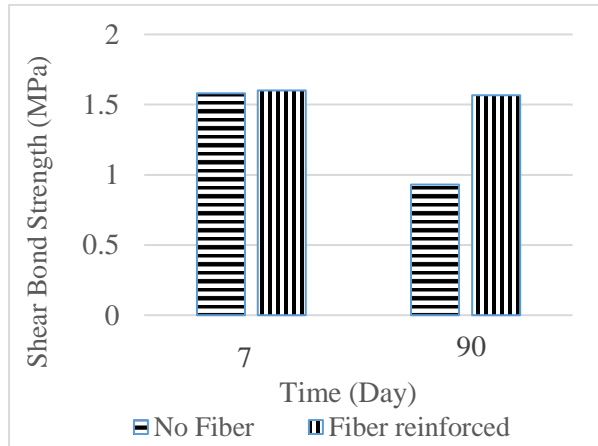
Fig. 6 Results of the "Twist-off" Test for M1 Mortar.

Figure 6 illustrates the results of the twist-off test used to determine the shear bond strength for M1 mortar.

It is observed that adding polypropylene fibres to the mortar significantly increases the shear strength of the repair layer with the steel substrate. However, there is little difference between their strength at the age of 7 days when the samples have just been processed and extracted. The addition of fibre to the mortars cured with water increased shear bond strength between the repair mortar and steel substrate to 68.5% at age of 90 days. Compared to mortars without fibres, the increase in shear bond strength of mortar with fibres is due to the increased crack width control and fibre shrinkage. Figure 7 illustrates the results of the twist-off test to determine the shear bond strength for M2 mortar.

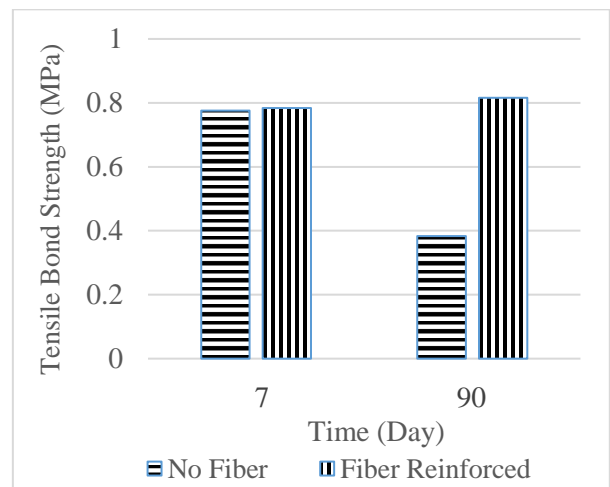
Fig. 9 Results of the "Pull-off" Test for M2 Mortar.

Figure 9 illustrates the results of the pull-off test used to determine the tensile bond strength for M2 mortar.

Similar to results obtained for M1 mortar, it was observed that adding fibres to the mortar significantly increases the bond strength, see “Fig. 9”. A comparison of mortars, those with and without fibres, indicated that the tensile bond strength of the samples with fibres and cured with water was 113% higher than the samples without fibres at the age of 90 days. Overall, the data shown in “Figs. 6 to 9” indicate that adding fibres to mortars has a significant effect on the shear and tensile bond strength between the repair mortar and steel substrate, resulting in a general improvement. It is also observed that the difference in the amount of 7-day adhesion for ordinary mortars and fibre-reinforced mortars is very small. However, the adhesion of these two types of mortars at the age of 90 days is very high. Due to the fact that the mortars have been cured in water for 7 days, so in this time, there has been no shrinkage in the mortars, and therefore the fibres have not had much effect on the adhesion between the mortar and the steel. But at the age of 90 days, the fibre-free mortars have shrunk a lot and therefore their adhesion resistance has decreased. However, for fibre-reinforced mortars at the age of 90 days, the fibres prevent the cracks from opening too much inside the mortar, which prevents the falling of adhesion between the mortar and the steel. Therefore, at the age of 90 days, a big difference between the adhesion of ordinary mortars and fibre reinforced mortars is seen.

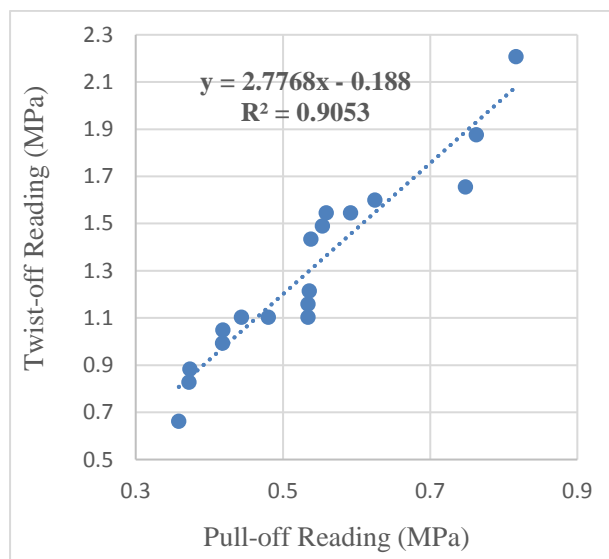
Fig. 12 Twist-off and Pull-off correlation.

Figure 12 shows the correlation coefficient between the results of the twist-off and pull-off test to measure the bond strength between fibre-reinforced mortars and steel.

According to the “Fig. 12”, the determination coefficient of “pull-off” and “twist-off” tests is 0.905. In addition, the correlation coefficient of two mentioned tests is 0.95. Considering the high correlation coefficient of the results of “pull-off” and “twist-off” tests, it is possible to obtain the results of one test and consider it for the other test. Therefore, the simple and cheap machine of the “twist-off” test can be used instead of the expensive machine of the “pull-off” test for determining the bond strength between the substrate and the mortars.

3- Considering the high correlation coefficient of the results of “pull-off” and “twist-off” tests, therefore, the simple and cheap machine of the “twist-off” test can be used instead of the expensive machine of the “pull-off” test for determining the bond strength between the substrate and the mortars.

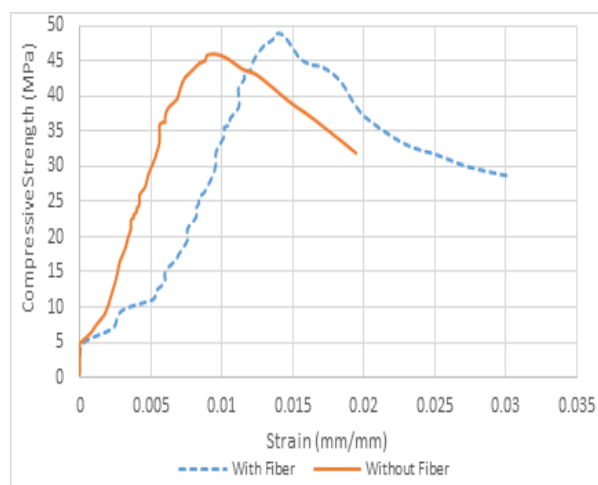
Fig. 13 A Comparison of compressive behavior.

Figure 13 presents the compressive behavior of ordinary and fibre-reinforced mortars. The sample containing polypropylene fibers failed at the stress of 48.8 MPa, while the ordinary mortar without fibers failed at the stress of less than 46 MPa. Moreover, the deformation tolerated by the mortar with fibre is 0.0142 at the peak of stress, whereas it is lesser for fibbers without mortar (about 0.0098), which is about a 45% reduction.

7- The examination of the compressive behavior of the mortars and the results of numerical modeling showed that the addition of fibbers improved the mortar behavior and increased the strength of mortar by tolerating greater deformation at peak stresses.

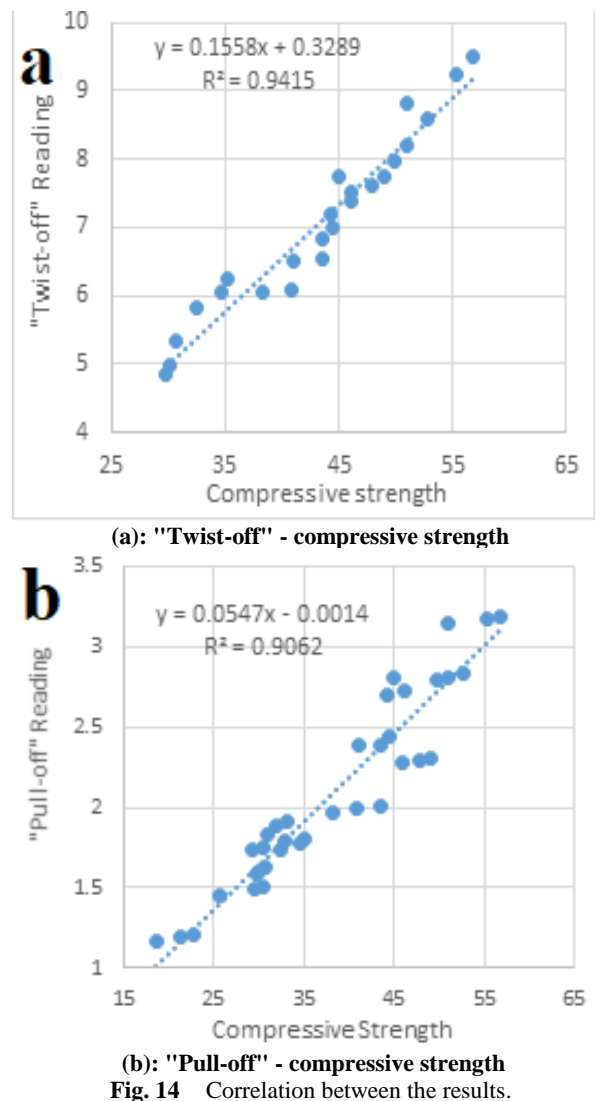
Figure 14 illustrates the coefficient of determination and the correlation between the compressive strength of mortars with the twist-off and pull-off tests.

Figure 14a illustrates that the correlation coefficient and coefficient of determination between the results of the twist-off test and the compressive strength of the repair mortar were 95% and 91%, respectively. Also, the coefficient of determination and correlation coefficient between the results of the pull-off test and the compressive strength were 84% and 91%, respectively. Due to the strong correlation coefficient between the results of twist-off and pull-off tests, with the compressive strength of the repair mortar, the compressive strength of mortars can be easily evaluated by using the above-mentioned tests under different conditions.

5- To evaluate the compressive strength of repair mortars, twist-off and pull-off tests can be used by placing the readings obtained in the equations $y = 0.156x + 0.329$ and $y = 0.055x - 0.001$ instead of x , respectively.
