Research Paper

Improving the Efficiency and Durability of Blast Furnace Air Tuyere Through Different Ceramic Coating Materials

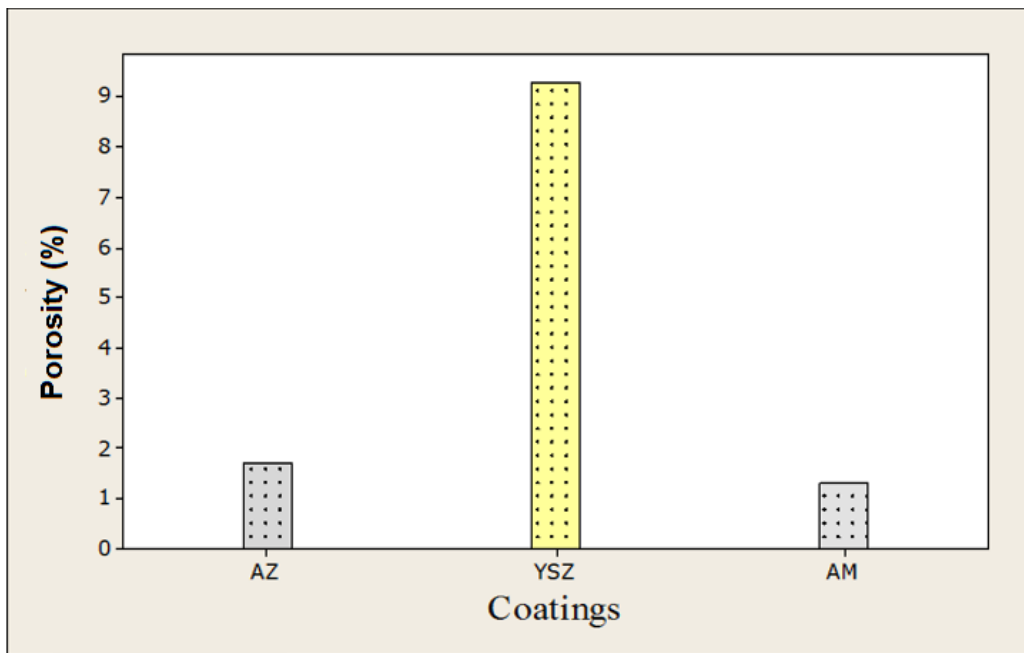
Figure 2. The average porosity of AZ, AM, and YSZ coatings

The cross-sectional microstructure and the thickness of the plasma-sprayed coating are shown in Figure 1, where, as observed, the three coatings do not have layered discretization. The microstructure of the AZ and AM coatings is denser than that of the YSZ. No cracks and layering are observed at the interface of the two coatings. The 9.31% average porosity of YSZ, the 1.7% of AZ, and 1.3% of the AM specimen are bar-charted in Figure 2.

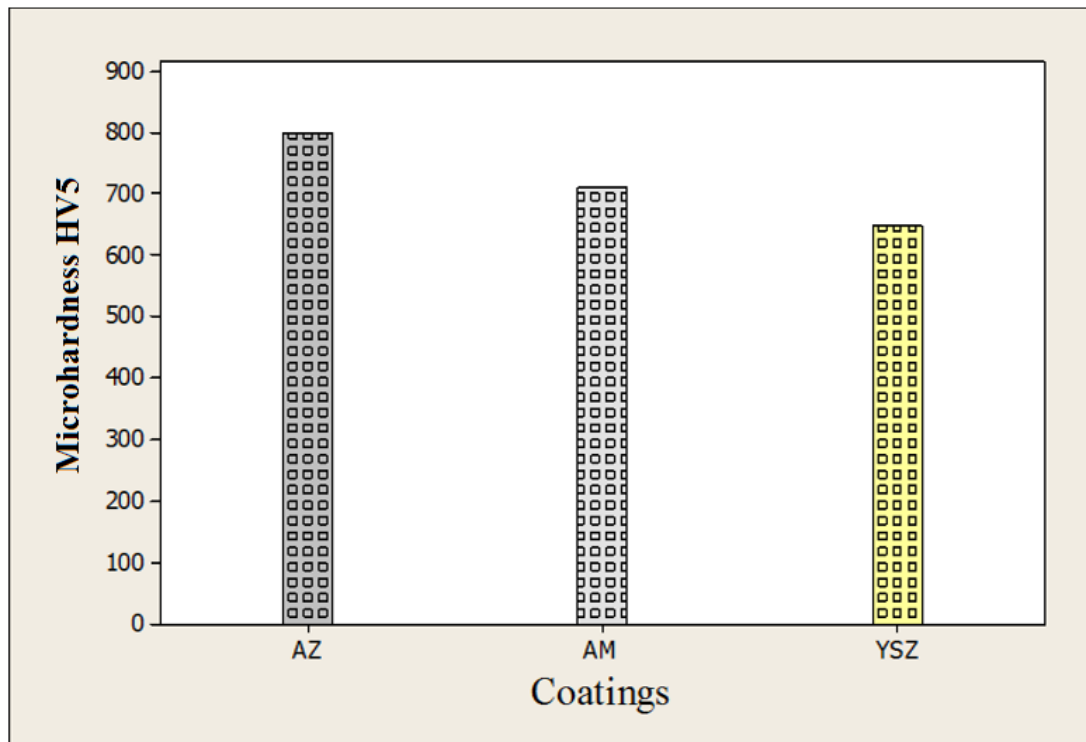
Figure 3. Average micro-hardness of AZ, AM, and YSZ coatings

The porosity of coatings applied by the plasma spray method is relatively high [24]. In general, the micro hardness values are considered an appropriate indicator of homogeneity degree and fusion in the structure. The average hardness values of these coatings are bar-charted in Figure 3, according to which it can be deduced that the lower the porosity, the higher the microhardness of the coating. As per Figures 1 and 2, the average value of microhardness of the AZ and AM coatings is greater than that of YSZ coating, due to their lower porosity.

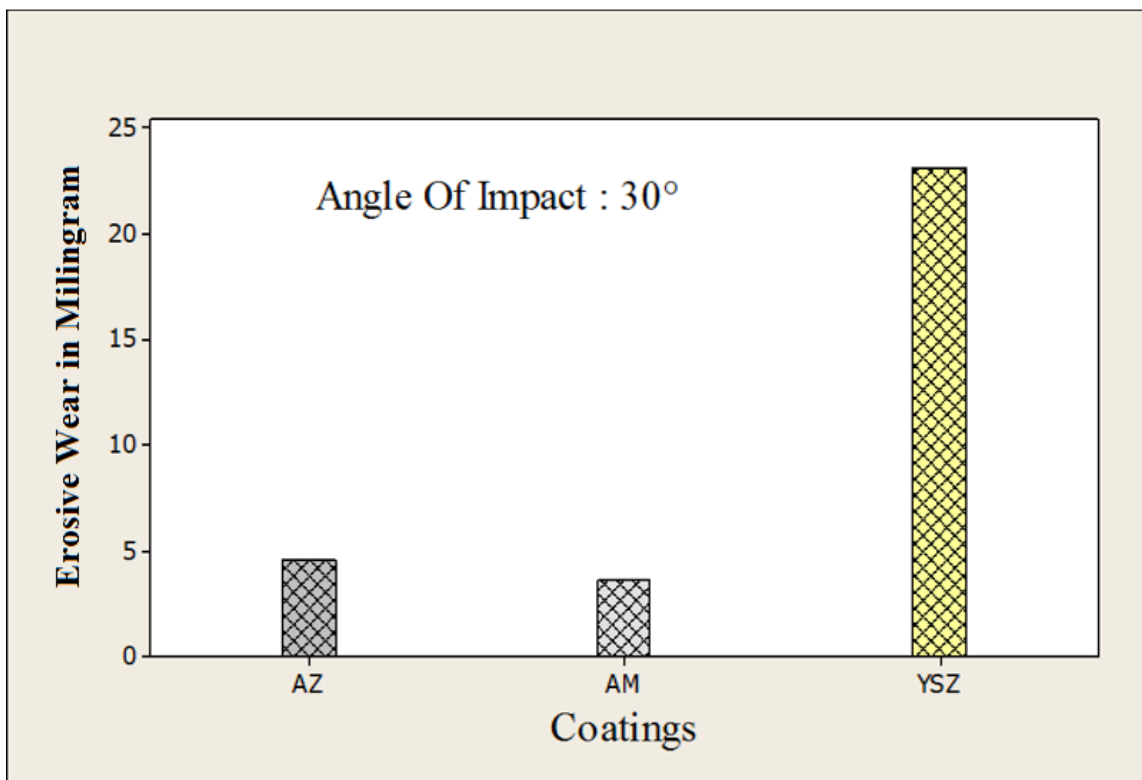
Figure 4. Coatings' average erosion based on the mass loss in mgr at a 70 m/s impact speed on the coating surface at 30°

AM ceramic coating outperforms the AZ, and the AZ ceramic coating outperforms the YSZ. These results are justified by the contribution of zirconia in improving the alumina hardness in the coating's microstructure. According to [26], the hardness of alumina ceramics hardened with zirconia compared to alumina hardness is four-fold. This phenomenon significantly contributes to erosion resistance enhancement. According to [25], YSZ coating has low microhardness due to higher porosity and low toughness [25]. The mass loss of the ceramic coating in (mg) 30 and 90° are bar-charts in Figs. (4 and 5). In all the AZ, AM and YSZ coatings, the maximum average abrasion loss at angles 30° is greater than 90°, which corresponds to the findings in [27].

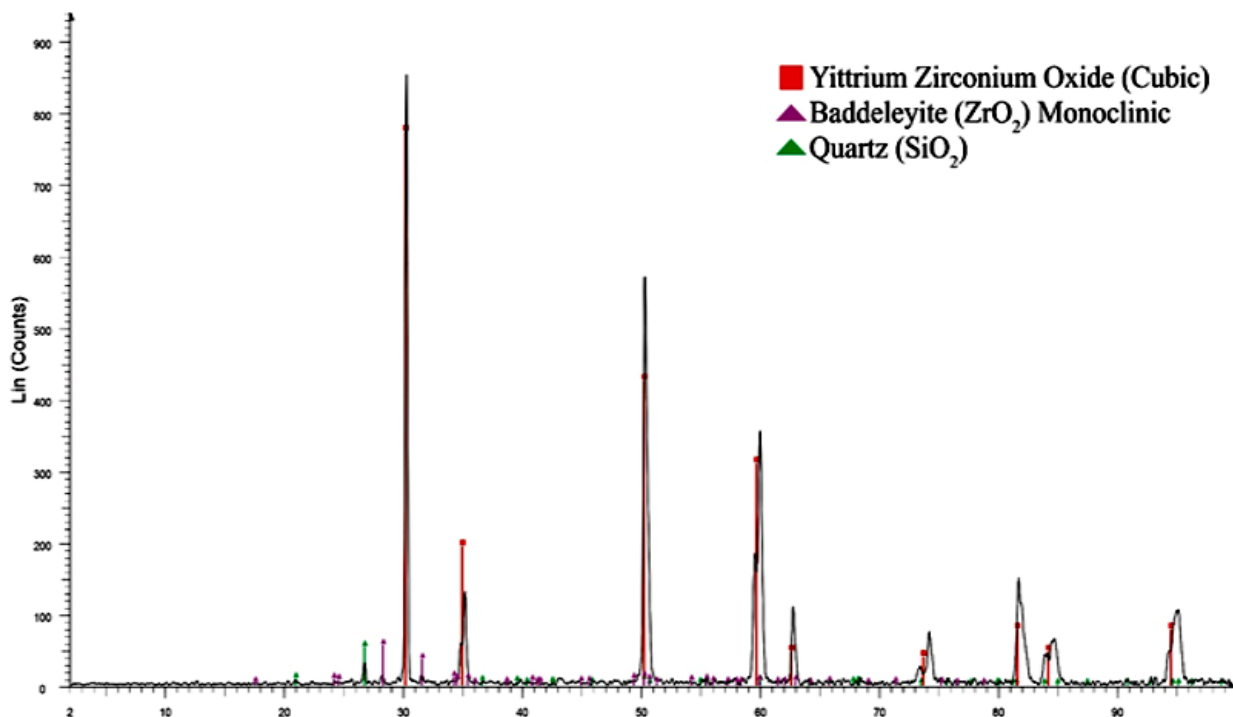
Figure 8. X-ray diffraction before placing the YSZ specimens into the furnace

The X-ray diffraction peaks before and after placing the AZ, AM, and YSZ specimens into the furnace are shown in Figs. (6, 7, 8, 9 10 and 11), where, as observed, a Fe_2O_3 peak appears in both coatings after specimens are put into the furnace. According to Equation 1 [10], the Fe_2O_3 phase is formed through the reaction between FeCl_3 and FeSO_4 , indicating that no reaction occurs between FeSO_4 and FeCl_3 and the coatings. The brown-colored areas in Figure 12 exhibit the Fe_2O_3 formation on the coating's surface after being put into the furnace.

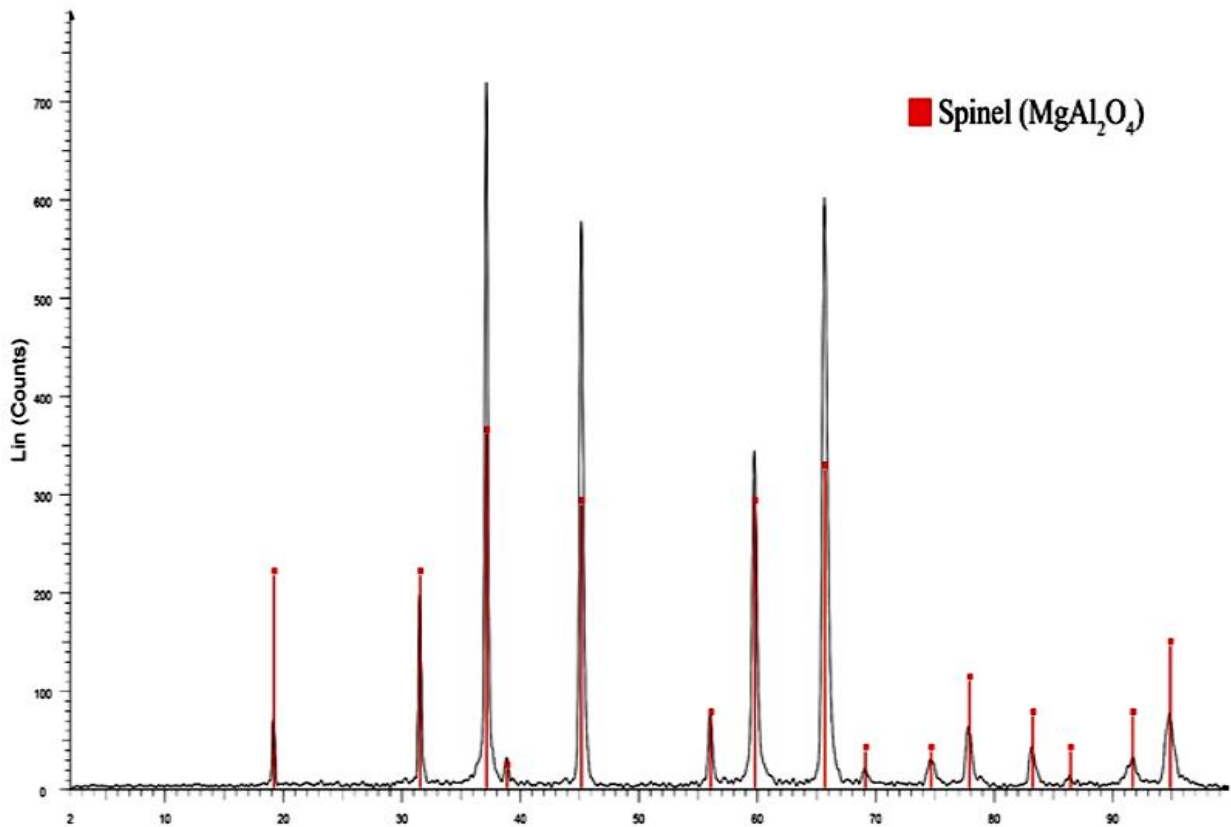
Figure 10. X-ray diffraction before placing the AM specimens into the furnace

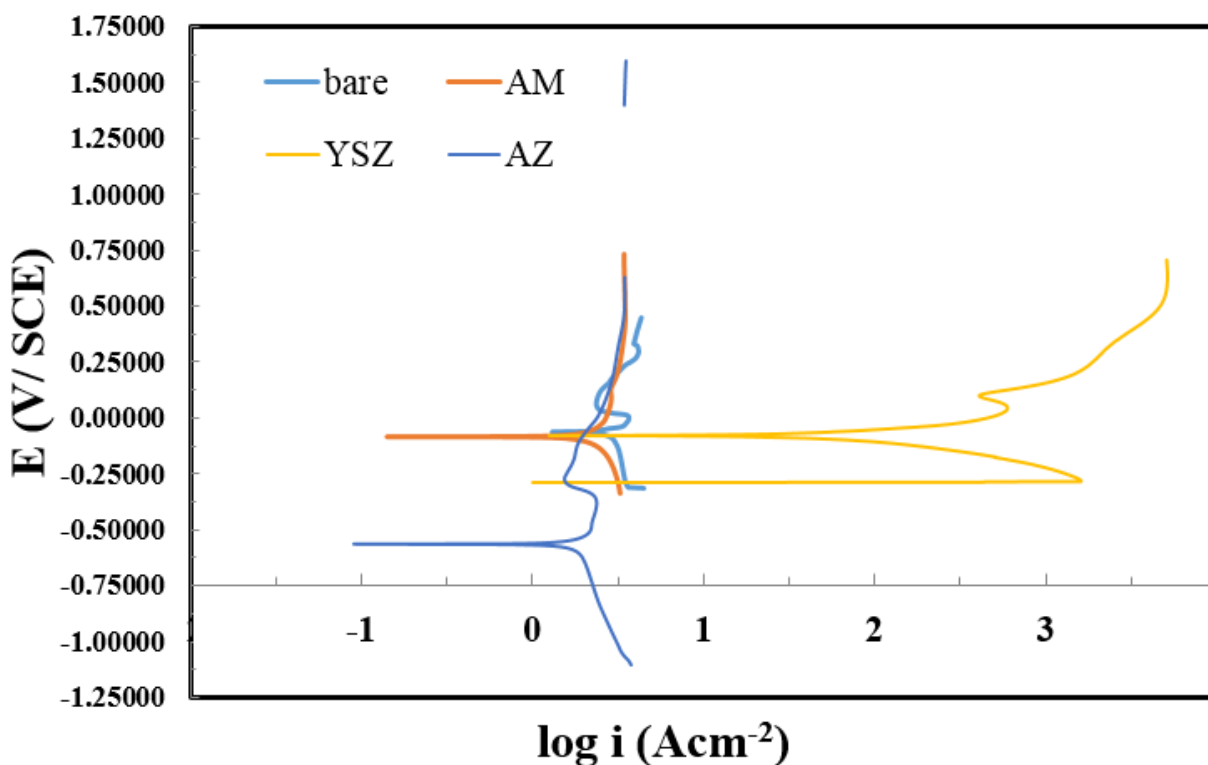
Figure 13. The polarization test of YSZ, AM, AZ, and bare specimens immersed in a salt solution of 50% wt% FeCl₃ and 50wt% FeSO₄.

According to Table 4, the YSZ specimen immersed in a salt solution of 50wt% FeCl₃ and 50wt% FeSO₄ has a very low corrosion current of 0.00029 microamperes/cm². Hence, compared to the bare specimen with a current density of 4.474 microamperes/cm², the YSZ specimen has better protection against corrosion and oxidation under the same conditions. Further, AM and AZ specimens outperform the bare specimen in terms of protection against corrosion in the same immersion conditions. These results confirm the good interaction of the coated layer of YSZ, AM, and AZ specimens with the copper substrate. Corrosion current densities are estimated based on the extrapolation of anode and cathode Tafel lines, the diagram of which has been displayed in Figure 13.

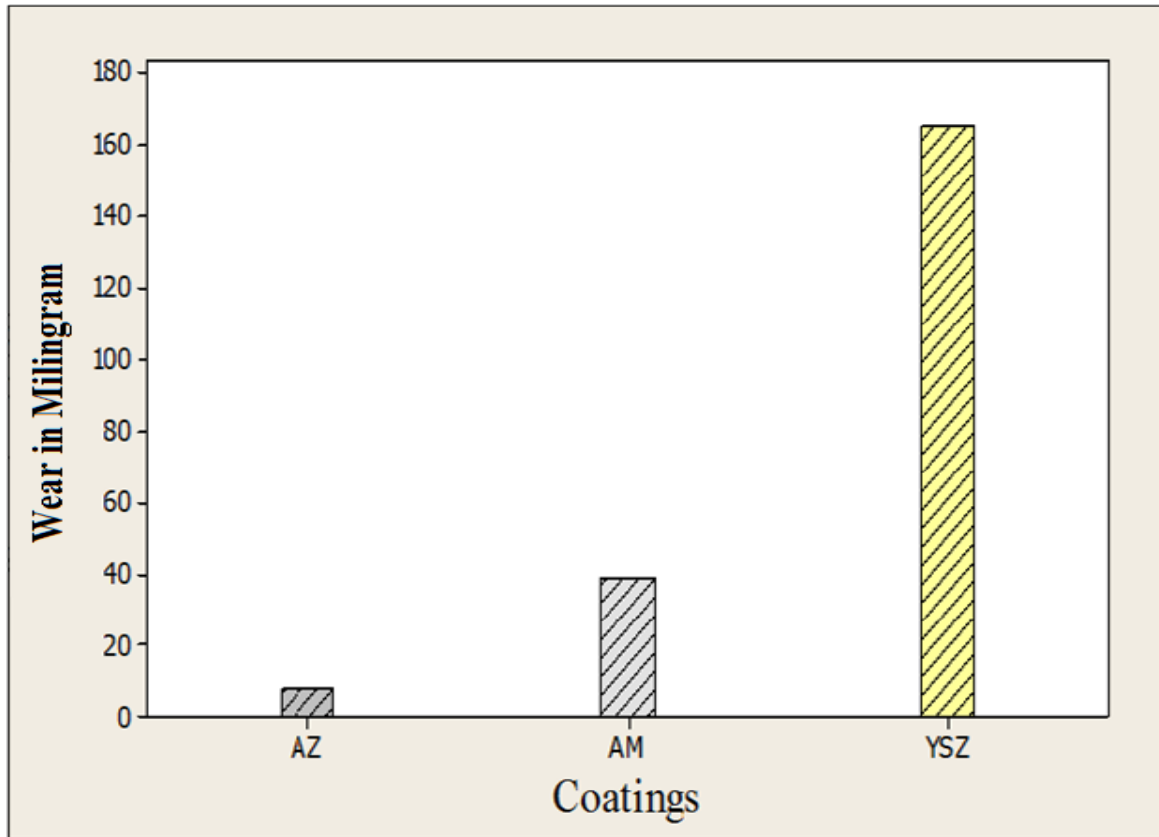
Figure 14. Mass loss average based on the mechanical abrasion test of AZ, AM, and YSZ coatings

This test is run to assure the coating scratch resistance when installing the blast tuyere. In this test, AZ coating undergoes higher abrasion resistance compared to YSZ. The results of this test are bar-charted in Figure 14 and termed the mass loss average.

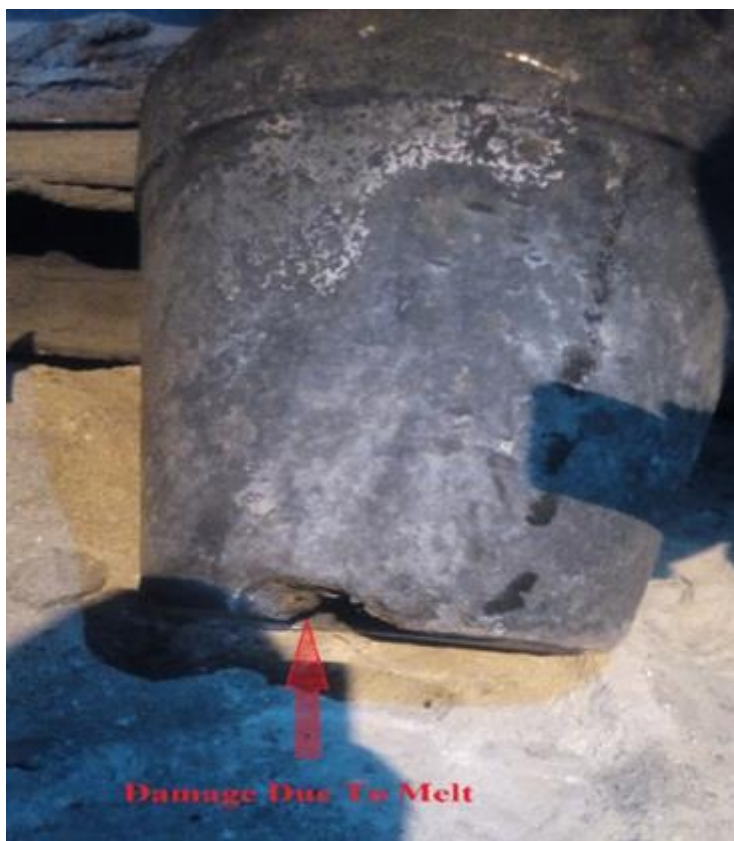
Figure 18. Newly developed tuyere with AM coating after damage and removal from the blast furnace

- The tuyere with AM coating is damaged after 45 days and replaced, while the tuyere with AZ coating is replaced after 170 days only due to the blast air passage blockage by slag and molten cast iron produced during blast furnace abnormal operating conditions. No damage was detected on the body and outer nose of the tuyere
- Based on the findings, the AZ coating is expected to be an appropriate coating for the blast furnace tuyere considering the metallurgical, mechanical, and thermal properties

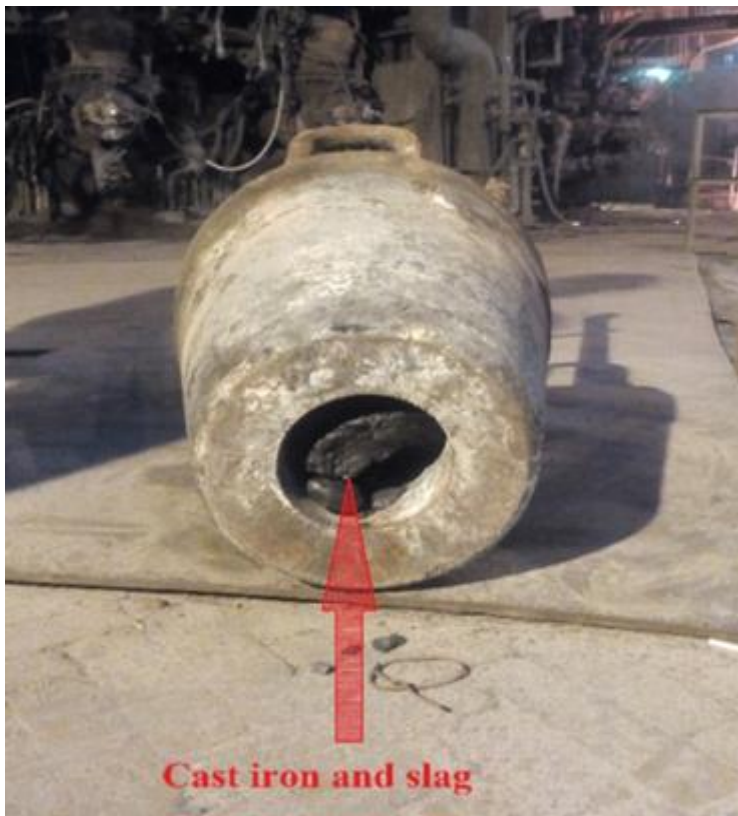
Figure 19. Newly developed tuyere with AZ coating after the blast air passage filled up with the melt and removal from the blast furnace
